# A Review of Australian and New Zealand Investigations on Aeronautical Fatigue During the Period April 2003 to March 2005

DSTO-TN-0624

## **ABSTRACT**

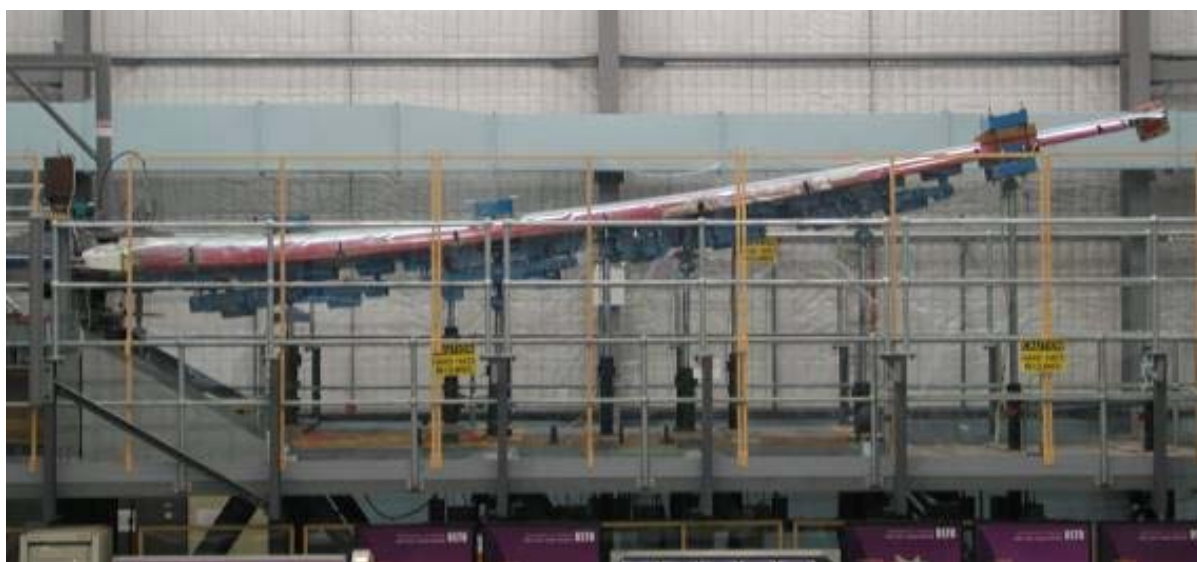
Figure

1: F-WELD Test Article Undergoing Cold Proof Load Test

The F-WELD (Figure 1) is a full-scale load sequenced fatigue test. Testing is being conducted on a short configuration F-111F wing designated A15-80L using a flight-by-flight 1,000 AFHR blocked spectrum representative of previous USAF in-service operations; in effect, the wing's usage is being continued to failure, providing a sound basis for further consideration of RAAF usage and other configurations. The test sequence consists of the application of two blocks of manoeuvre loading followed by Non Destructive Inspection (NDI) followed by the application of Cold Proof Load Test<sup>2</sup> (CPLT) prior to the application of a further two blocks of loading.

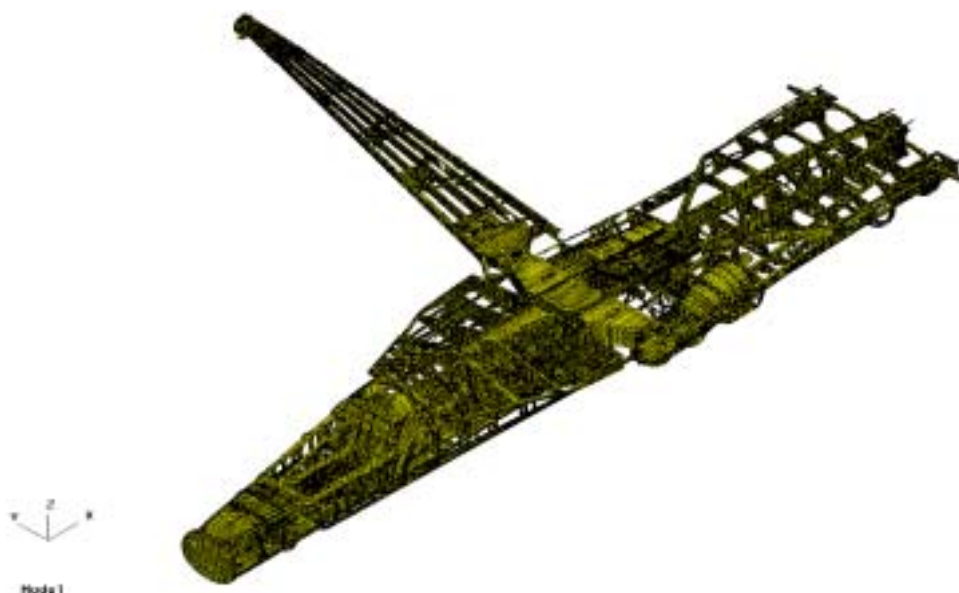
Figure 1: Major structural components of F-111 Internal Loads Model.

The F-111 FEM is known as the Internal Loads Model (ILM), and one of its primary roles is to provide accurate free body loads for the stress analysis of fine grid FEM's. The ILM is an MSC NASTRAN model with 396,708 elements, 318,318 nodes and approximately 1,870,000 degrees of freedom. A picture showing the main structural elements of the ILM is shown in Figure 1. The results are subsequently used to enable DADTA's to be performed on critical structure of the F-111 airframe. These DADTA results are used to determine inspection intervals, which underpin the structural management philosophy of the fleet by Safety-by-Inspection (SBI).

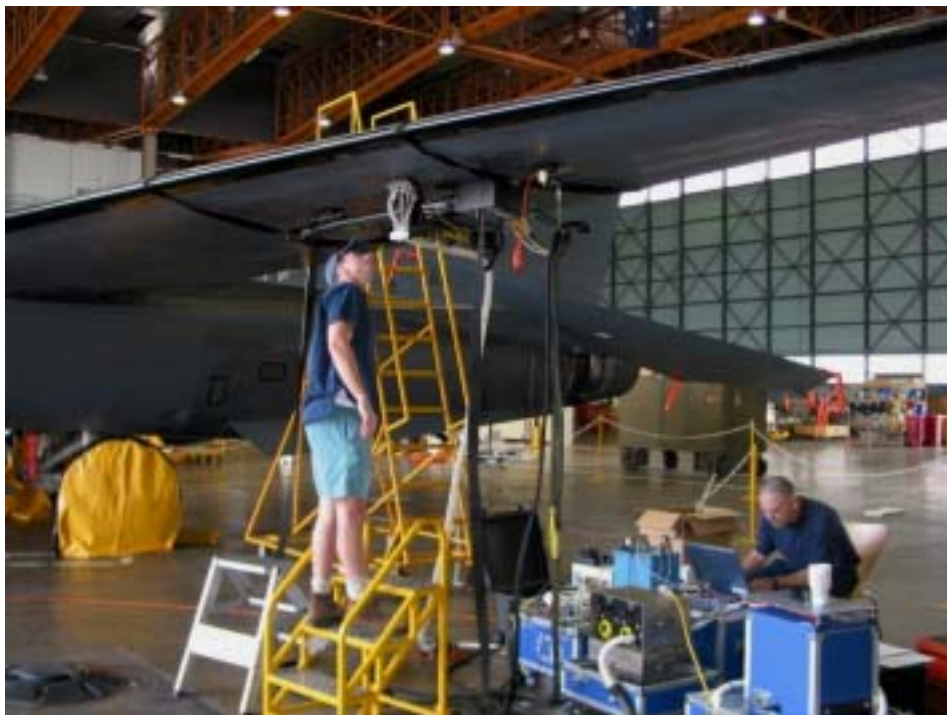
Figure 2 Automated ultrasonic inspection of Taper-Lok fastener holes in an F-111C wing using the SAIC Ultraspect-MP system.

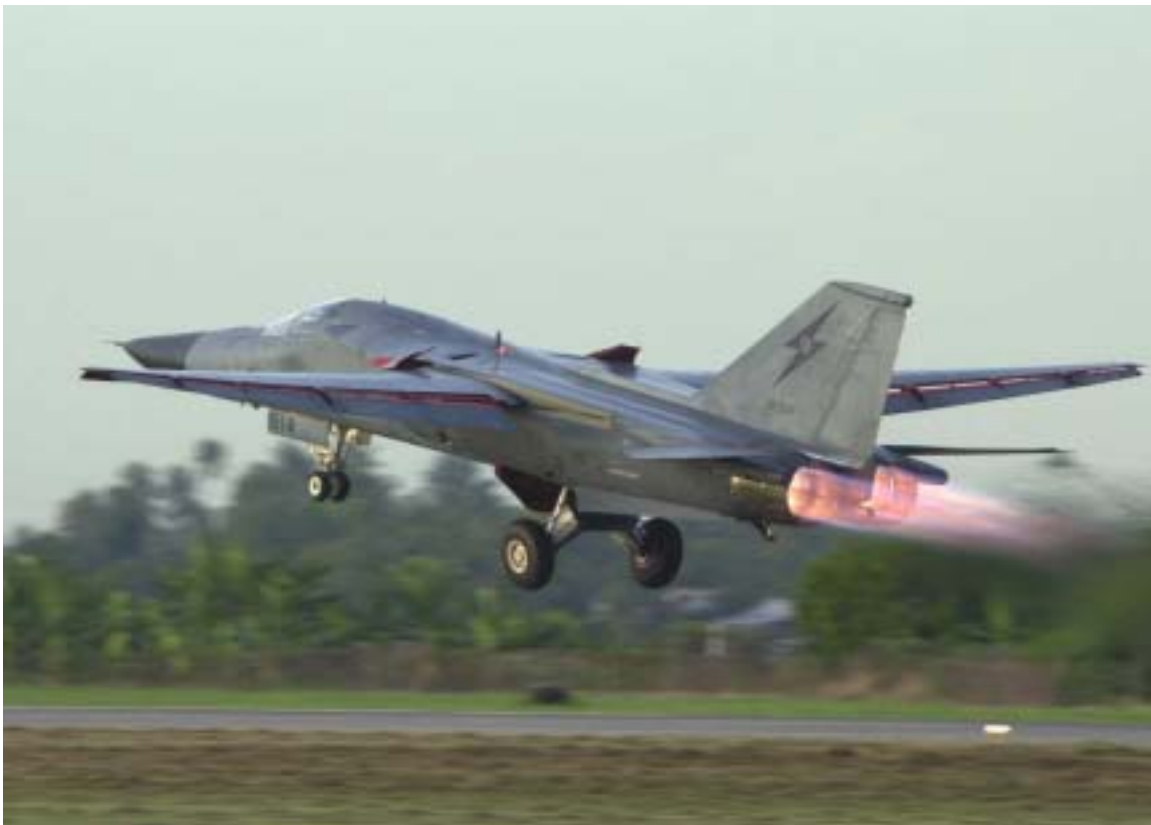
*Figure 1: Position of strake - fin on bottom side of rear fuselage*

Figure 1 shows position of the strake – the fin on bottom side of rear fuselage. Figure 2 shows a failed strake next to a good one. Figure 3 shows two failures - failure occurred by fatigue of the aluminium mounting plate member, from the front working backwards. Note the similarity of the two failures about 18 inches in a total length of 24 inches was cracked, although there were smaller fatigue cracks in the "overload" region, around the side of the section. Figure 4 shows visual detail of typical fatigue region near front - fatigue cracks start on the upper radius and work there way down the length and through the section thickness. Figure 5, SEM striations on fracture surface - vibrational loading with occasional large load (i.e. high G turn). Unfortunately, there is no information on the time frame of G turns so it is difficult to obtain the rate of growth - although we can conclude that the 18 inch cracks have probably been growing since new (after an "incubation" period). Figure 6 shows a smaller fatigue crack in "overload" zone at rear.

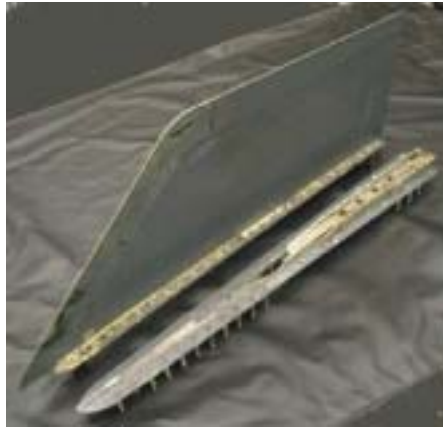
*Figure 2: Failed strake next to a good one.*

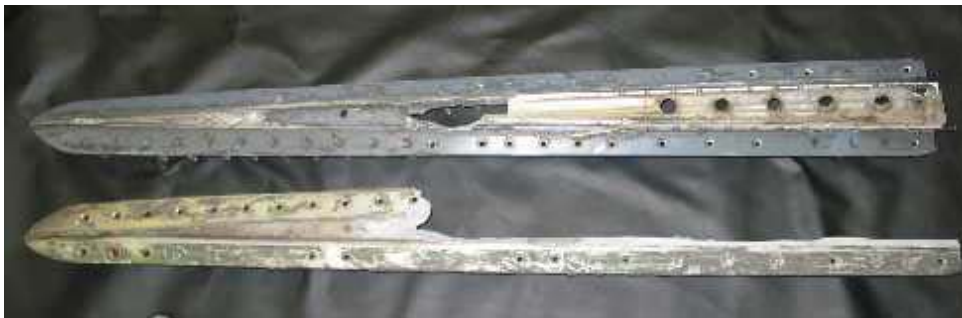
*Figure 3: Two failures.*

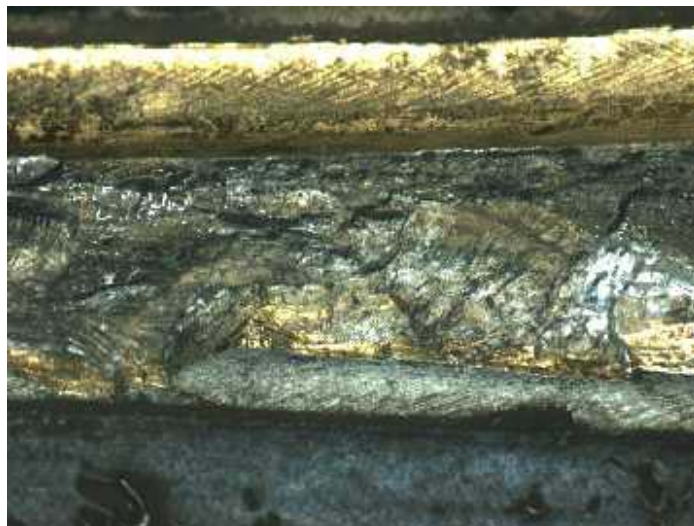
*Figure 4: Detail of typical fatigue region.*

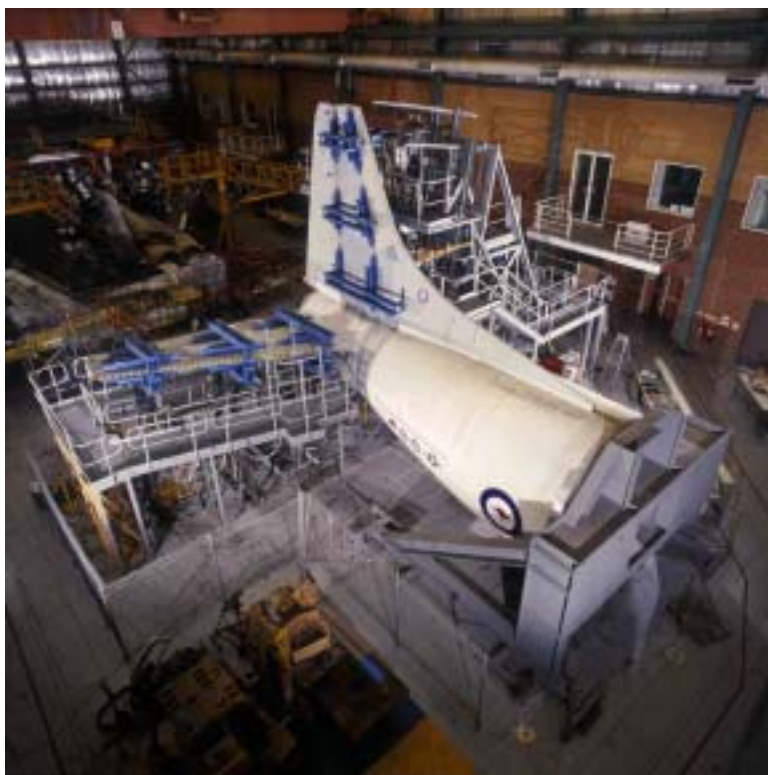
As part of Australia's contribution to the international P-3 Orion aircraft Service Life Assessment Program (P-3 SLAP), DSTO undertook the full scale fatigue test of the empennage section of the aircraft. The test cycling phase commenced in January 2002 and was completed, along with residual strength testing and a post-test teardown, in July 2004. The test article consisted of the fin, tailplane and aft fuselage from a retired airframe. Loads were applied via a total of 27 hydraulic actuators, to a 15,000 flight hour load spectrum that represented one lifetime of aircraft usage to a USN 'severe' spectra. Cycling was applied for two lifetimes, at which point little fatigue damage was observed in the primary structure. In order to explore the possibility of providing additional test clearance for life extension, and to provide a test basis for DTA based inspection locations and intervals, further testing at augmented load levels was then commenced (Reference 1). Transport aircraft fin and tailplane loads during normal operations are generally much lower (perhaps as much as 50%) than the static design limit load cases that generally include abnormal events such as engine-out. This results in low in-service stresses, which in turn require either a long testing time or significantly augmented loads in order to provide typical fatigue failures. Fortunately these same low stresses allow the loads to be raised significantly before unrepresentative local residual stresses can give misleading effects. The load factor finally applied was 1.6, with clipping at 1.1 times the maximum unfactored loads for the fin and 1.5 times the maximum unfactored loads for the tailplane. Under the augmented load sequence a major failure was generated in primary structural at the root of the fin. Cycling of the tailplane then continued, including the insertion of saw cuts, and further fatigue cracks were generated after another 15,000 hours. The test concluded with residual strength testing to a number of limit load cases and a full teardown. Coupon testing supported the interpretation of the test findings back to in-service load levels and the test failure locations and times enabled fleet management actions to be developed.

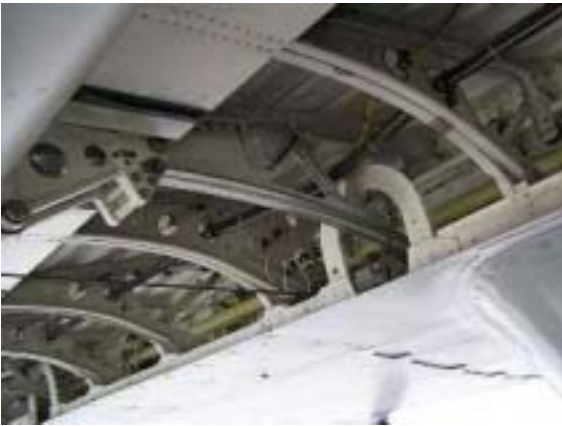
*Figure 1: Flap track*

DGTA investigated the failure of a P-3C Orion flap track. Figures 1 and 2 show the position of the flap tracks on the Orion aircraft (Flap Track Station 174 on the port side). The picture was taken while the aircraft was grounded in Hawaii where the complete separation of the flap track was noticed.

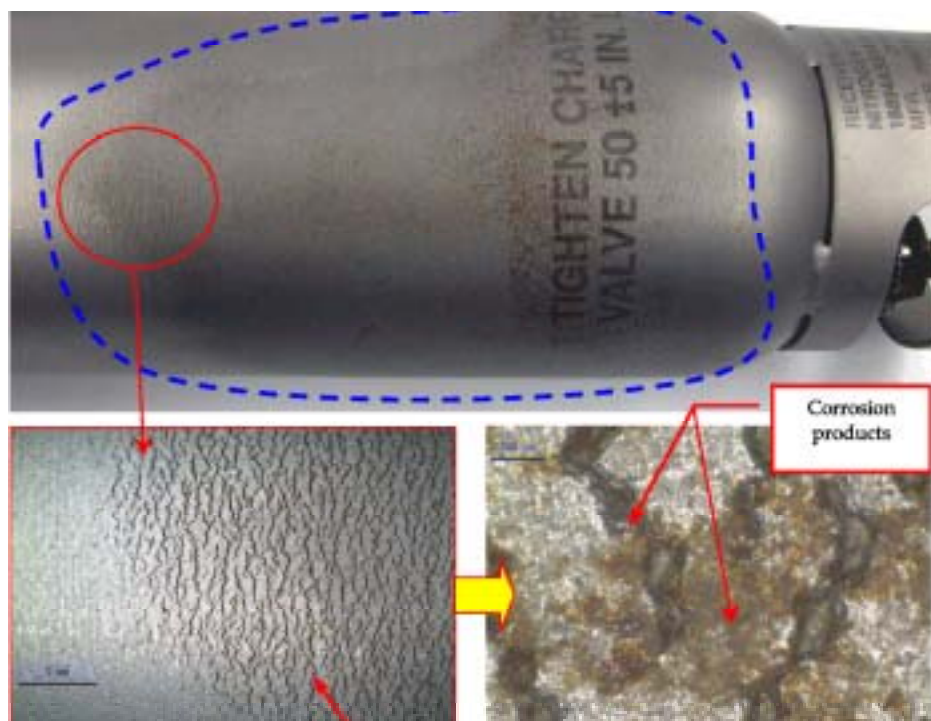
(Top) Photograph of a subject cylinder showing a large area of cracking (circled area). (Bottom left) An enlarged view of the cracking showing a network of circumferential cracks. (Bottom right) Note the corrosion products (i. e. 'rust stain') inside and in the vicinity of the cracks (arrowed).

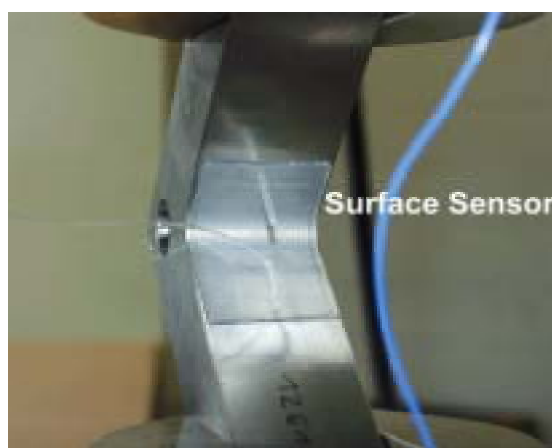
*Figure 3. Surface sensor on a concave curve test coupon (from 1.)*

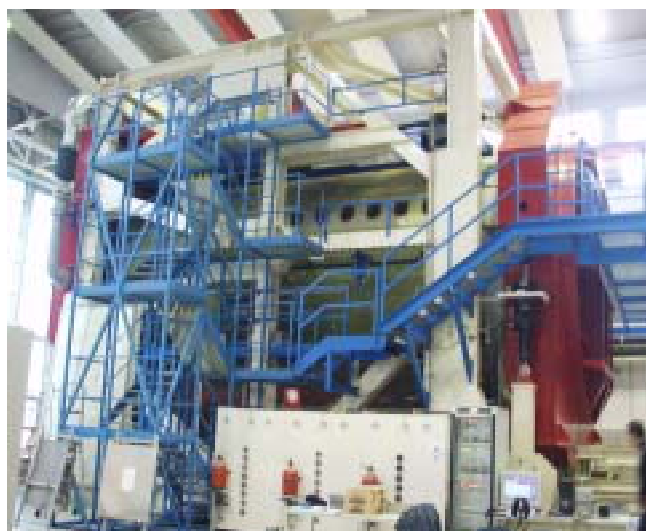
*Figure 4. TANGO barrel test facility (from 1.)*

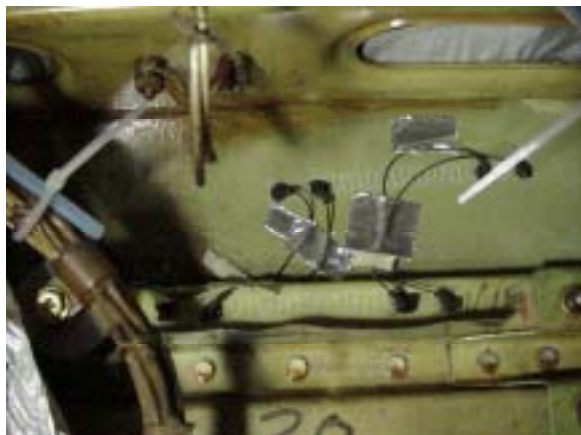
**Figure 5.** Surface sensors installed in the tail cone of a commercial DC-9 aircraft.

SMS has commenced a program with Boeing, Airline Operators and the FAA to have the CVM™ technology entered into the NDI Standard Practices Manual (SPM) for Boeing Commercial Airplanes. Once published in the Boeing SPM, the technology will be available for use by operators of Boeing Commercial Airplanes on their aircraft. Sensors have been flying in the tail cone (Figure 5) and baggage compartment of a commercial DC-9 aircraft for over a year as a precursor to this program.

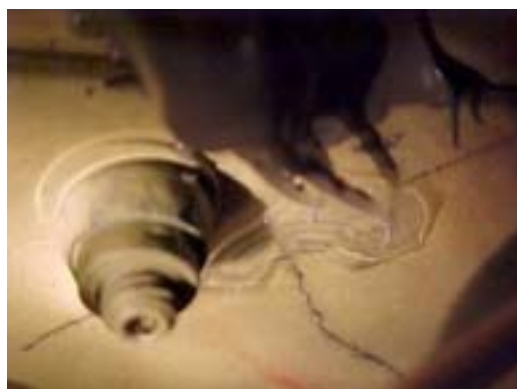
**Figure 7.** Sensor used to monitor crack growth in the US Navy H-53 helicopter

SMS is working with a number of other military fleet operators to validate the technology for use on their fleets of aircraft. CVM™ sensors (Figure 7) have successfully detected consecutive crack growth three times over a two year period on a US Navy H-53 helicopter based at Patuxent River Naval Base. The SMS UK operation is working with the UK Ministry of Defence for trial and commercial programs on military aircraft.

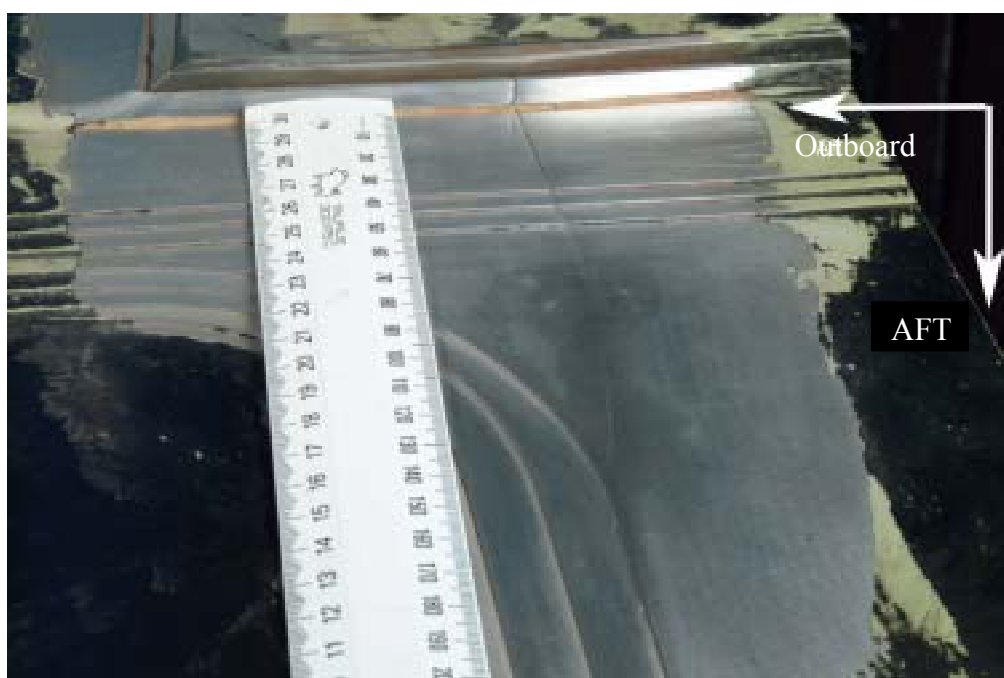
**Figure 2.** *View of the crack propagating beyond the doubler.*

The crack was visible on the under surface of the blade and extended through the leading edge, under the lower steel doubler and extended approximately 6 inches aft of the doubler (Figure 2). Upon removal of the doubler there was evidence of extensive disbonding and significant fretting on both the doubler and blade (Figure 3). To assist in exposing the fracture surface of the crack, saw cuts were made into the blade at the trailing edge and through the upper doubler, and the blade loaded in pure tension (Figure 4). In Figure 4, the inner end of the cracked blade has been loaded in tension to induce approximately the same degree of crack opening displacement as indicated by witness marks on the grip pad. The helicopter had evidently been flying with the crack in this configuration. The defect was much less visible when the rotor was stationary as the crack was closed by compressive forces in the lower blade surface.

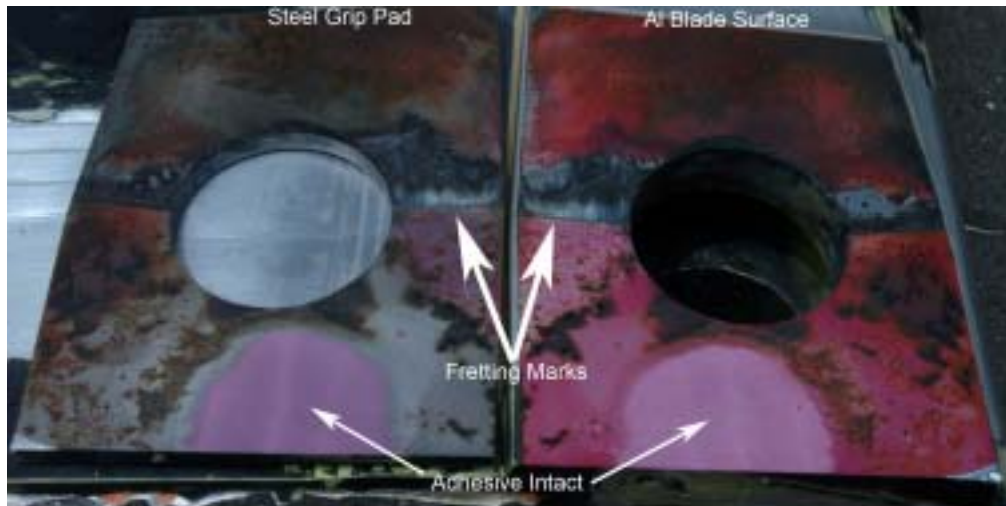
**Figure 3.** Adhesive surfaces after removal of the grip pad (left). The fretting marks indicate the crack opening displacement experienced in flight.

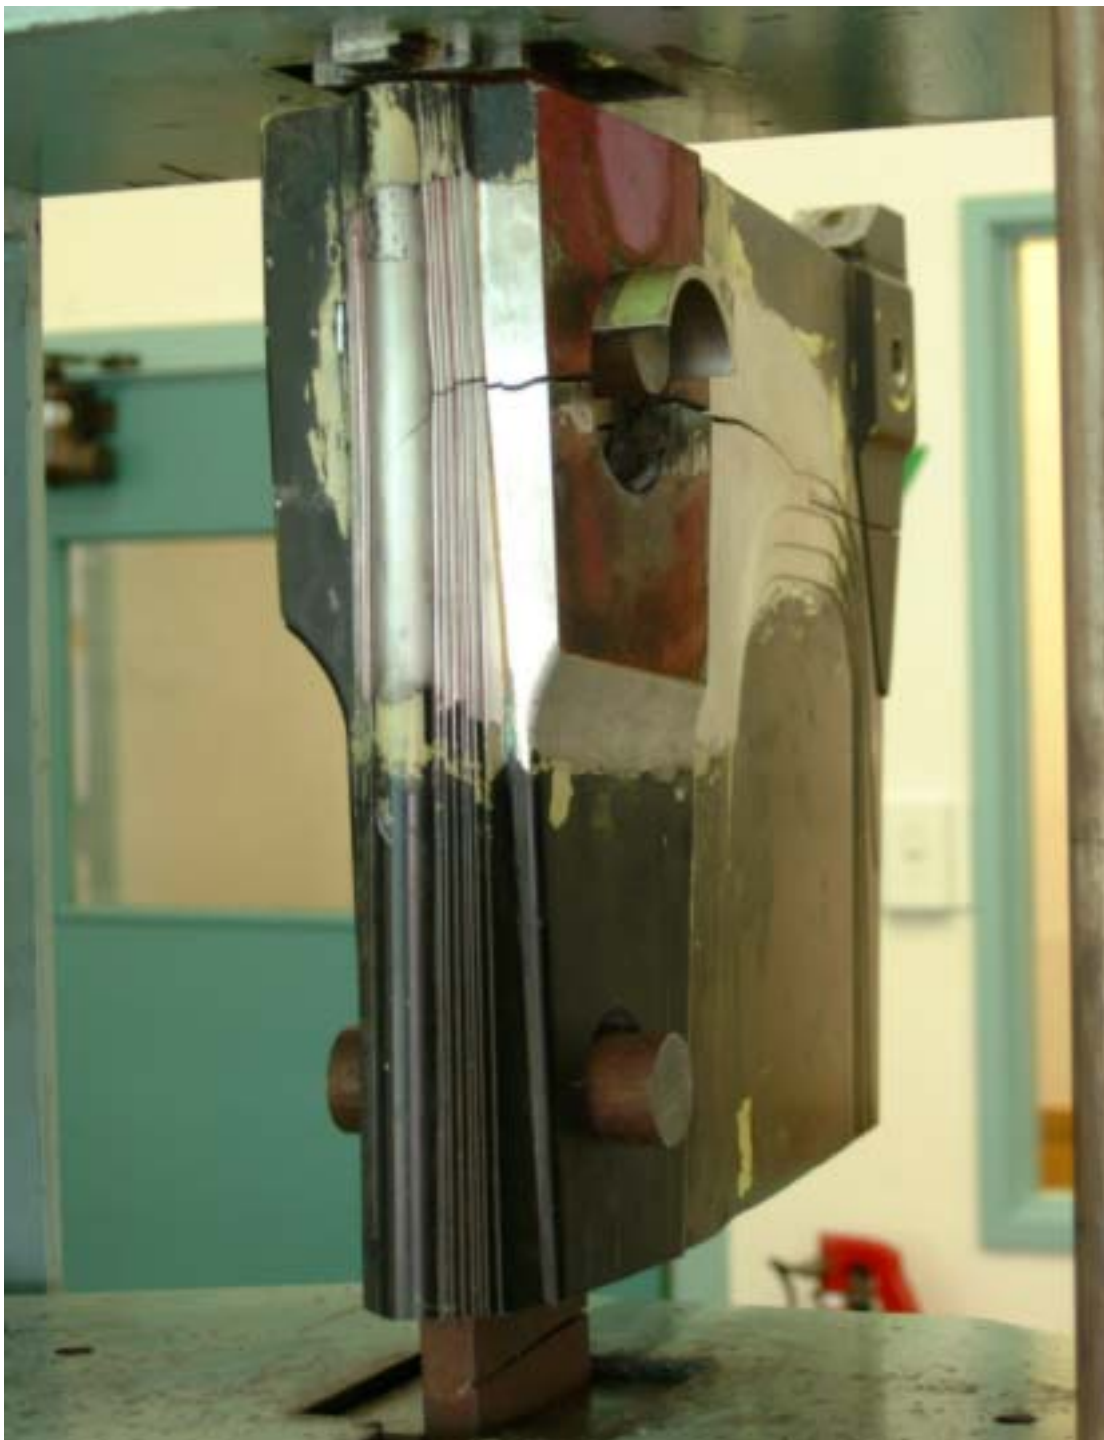
*Figure 4. Application of a tensile load to simulate the crack opening displacement indicated by witness marks on the doubler. The aircraft was likely to have been flying with the crack in this configuration.*
